HABITAT ENHANCEMENT

Habitat Enhancement: Dave Marshall Salmon Reserve

CHEAKAMUS RIVER RECOVERY

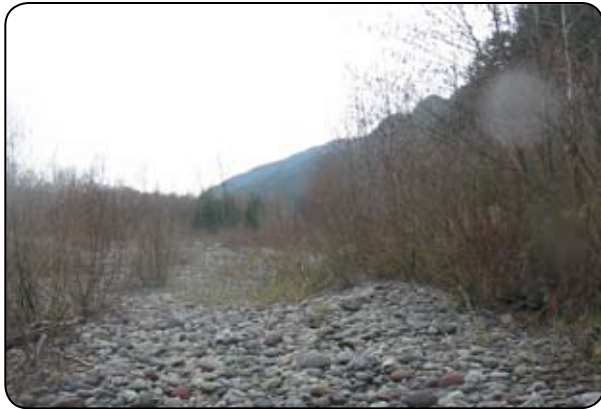
Many of these channels were damaged by record high water in the fall of 2003. Extensive bedload deposits and infilling of the Mile 49 Channel caused the isolation of the upstream end of the channel making it accessible to fish only during very high water. In addition, the flood damaged or displaced numerous instream large woody debris structures in the two Gorbusha channels.

Mile 49 Channel pre-enhancement

- Extensive excavation to reconnect channel to mainstem and re-establish appropriate pool depths
- Installation of large woody debris structures to increase cover
- Channel widening and excavation resulted in an additional 1087 m² of new wetted channel area

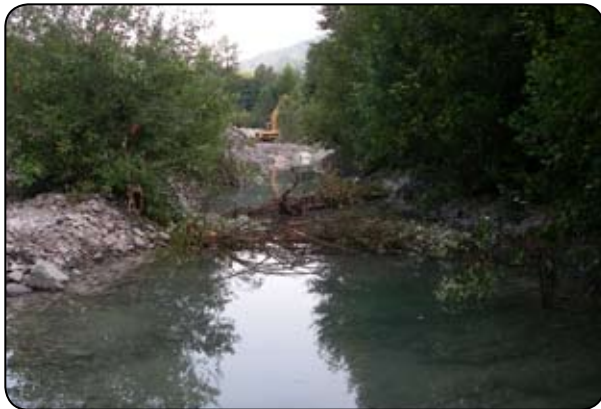
Mile 49 Channel after re-wetting

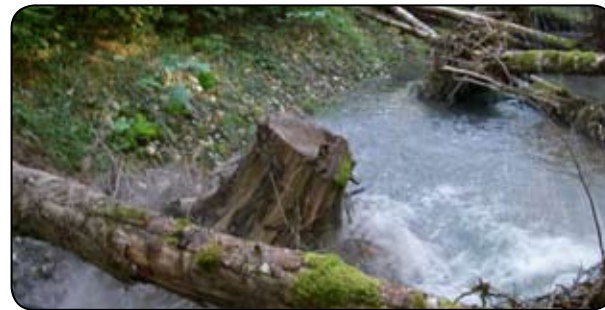
Woody debris structure

- Replacement and reconstruction of large wood debris structures to create suitable habitat and desired hydraulic effects
- Gorbuscha Channel
 - Eighteen new cover structures created and 14 structures repositioned to improve function as fish habitat
 - Large boulders placed to enhance juvenile rearing habitat
 - Twenty-boulder clusters positioned to break up flow patterns and maximize foraging and resting areas
 - An estimated increase of 132 m² of available cover habitat for stream rearing fish

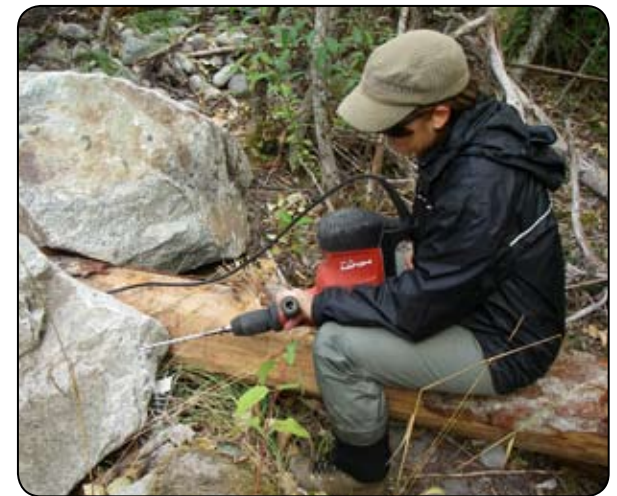
Creating boulder anchors for woody debris structure

- Channel constructed in 2004, therefore not affected by high water in 2003
- Habitat enhancement included:
 - New large woody debris structures
 - Enhancement of existing structures
 - Boulder placement in selected riffles
- Ten new cover structures created and 2 structures improved to increase fish habitat
- Two types of large woody debris structures installed, each seeded with smaller woody debris to increase complexity
 - Ballasted triangular structure
 - Double parallel log structure
